CASE STUDY

BELOW GROUND BASEMENT CAR PARK CRACK REPAIR

APPLICATOR: Waterproofing Concepts Limited, Christchurch
CLIENT: Charles Luney House, Christchurch
PRODUCTS USED: Sika® Injection 101-RC, Sika® Injection 201-CE, Sikaplug®, Sikadur® UA

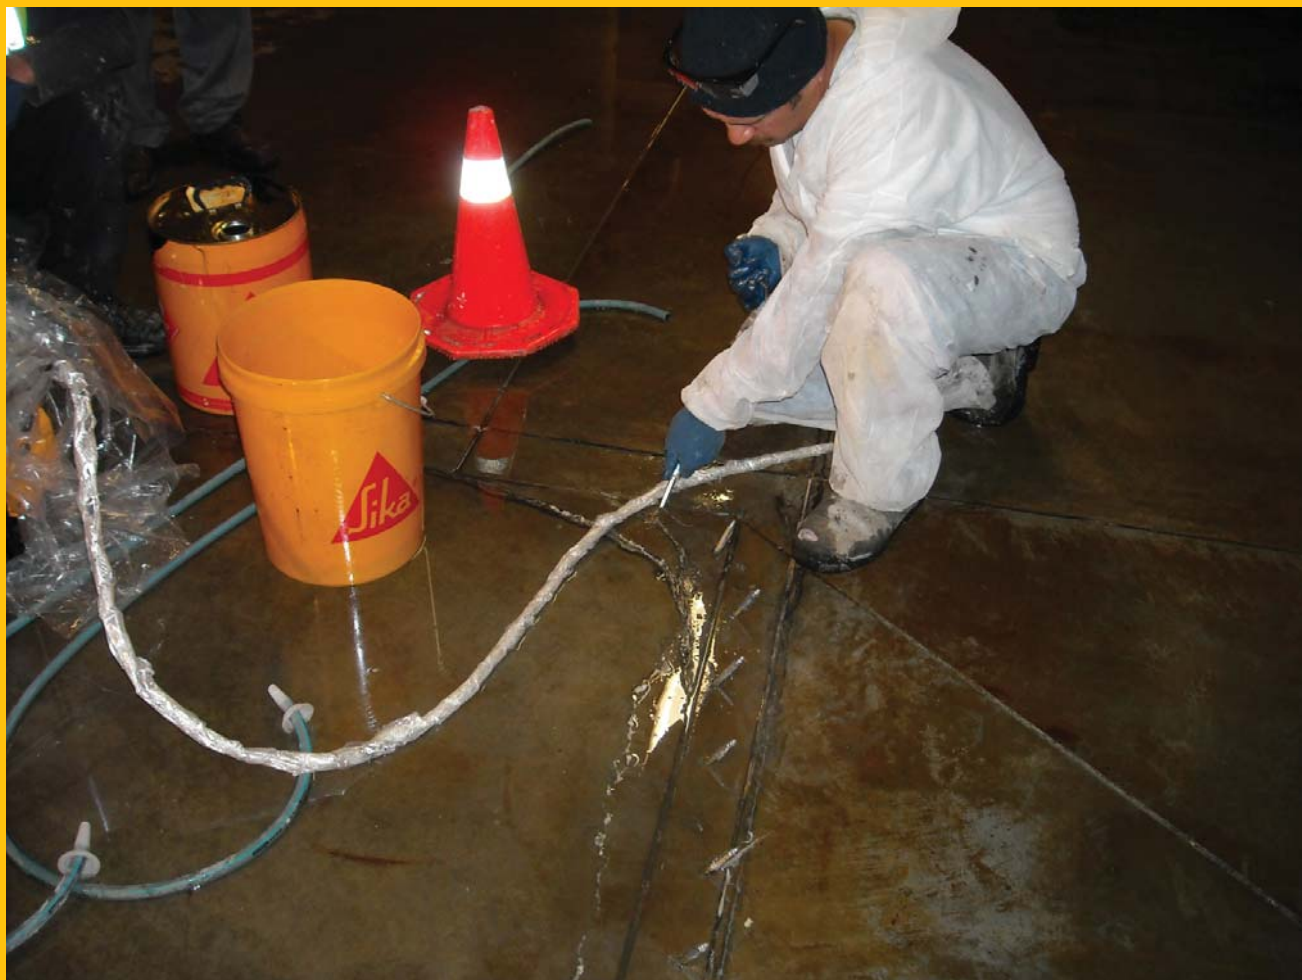
Charles Luney House was one of many buildings damaged during the September 2010 Darfield earthquake. Cracks appeared in the basement carpark and water was forced in under hydrostatic pressure, including one substantial crack where the water was flooding across the floor.

Waterproofing Concepts Ltd used Sika injection resins to stop water flowing from a substantial crack in a below ground basement car park.

Because there was a constant water flow, Sika® Injection-101-RC (a low viscosity, fast foaming and solvent-free water-reactive polyurethane injection foam resin) was used as a temporary water-stop. This then allowed the subsequent installation of Sika® Injection-201-CE to create a permanent watertight seal with some flexibility to absorb limited movement.
